## MONTEZUMA CASTLE

## Preservation: Montezuma Castle

## FACT SHEET

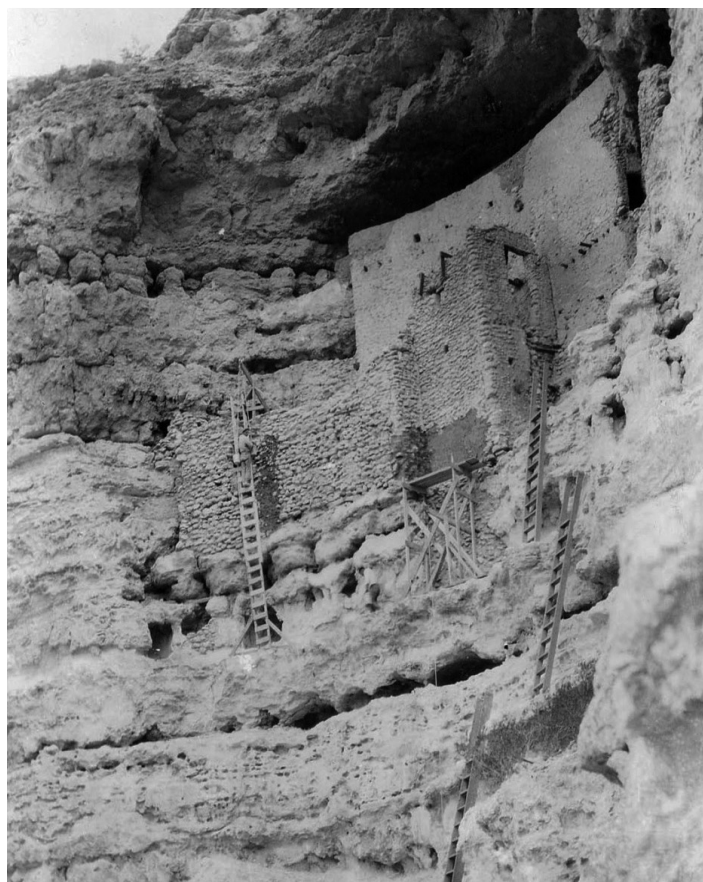
Making repairs to Montezuma Castle, 1923.

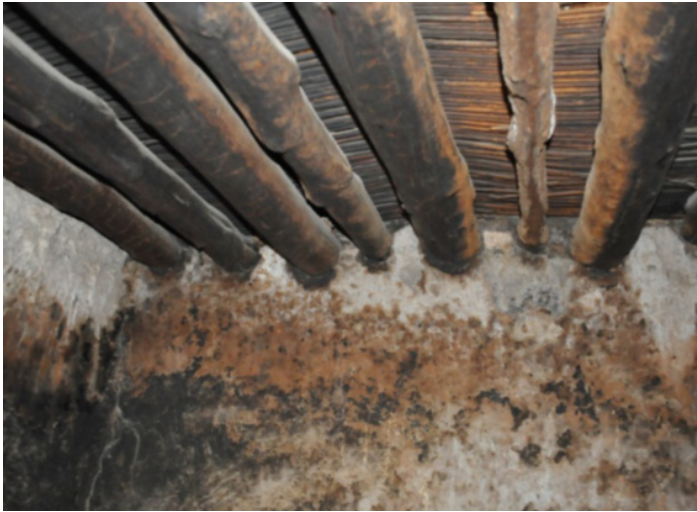
Healthy beams and a salt damaged beam in Room 1 (Level 4). The damaged beam also has significant beetle damage and severe wood defibration.

Despite stabilization efforts, the Castle is still susceptible to damage, with the original wood beams and plaster floors particularly vulnerable. Problems of concern within Montezuma Castle include powder beetle attack, water infiltration, soft rot decay, and wood defibration (break-down) from salt and mineral accumulation (Blanchett et al. 2010). Cracking and decayed wood have to be monitored frequently because beam loss could result in a room or multiple rooms collapsing.

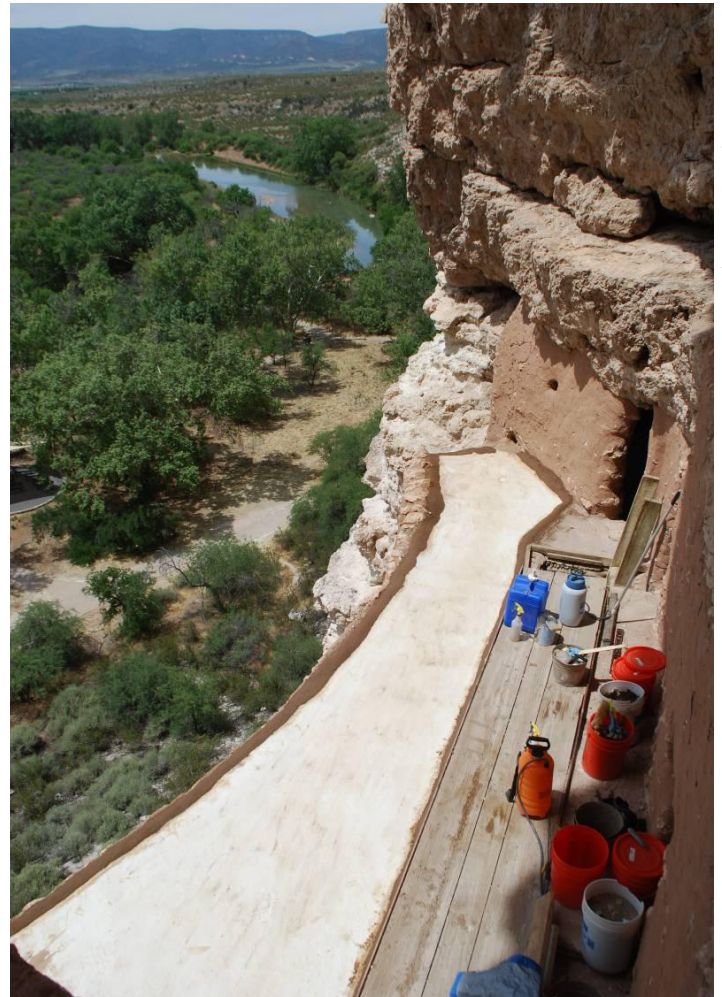
Pooling water is a major cause of damage to roofs, walls, and wooden elements. For Montezuma Castle, this has long been a problem for the roof of the second story. First repaired in 1897, when the Arizona Antiquarian Association placed a corrugated metal roof over the damaged area in an attempt to protect the interior, this same roof was again repaired in the 1920s, and most recently in 2011, when the National Park Service installed an Ethylene Propylene Diene Monomer (EPDM) membrane over the roof to prevent water from reaching the interior.

The second story roof of Montezuma Castle during repairs in 2011.
